Manhole Inspection Summary

Manhole # S25II_042MH

Insp Date: **8/28/07 11:51 AM**

Location Address: **2039 MADISON ST**

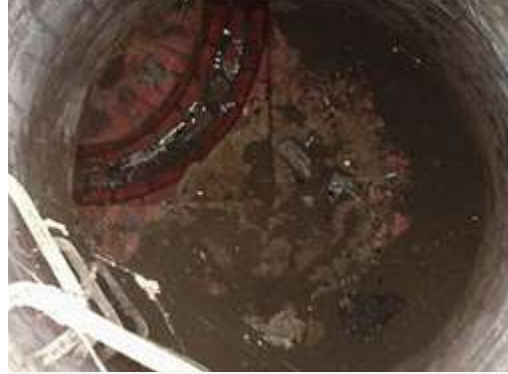
Top View

Corroded steps. Evidence of surcharge - Bench debris.

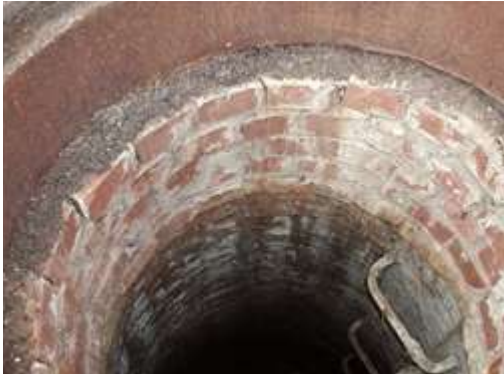
Defect

Frame leaks. Frame offset. Adjustment deterioration and infiltration. Corbel and Barrel infiltration - other side.

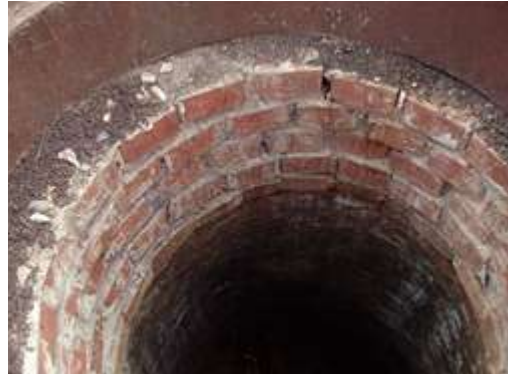
Defect

Frame leaks. Frame offset. Adjustment deterioration and infiltration. Corbel and Barrel infiltration.

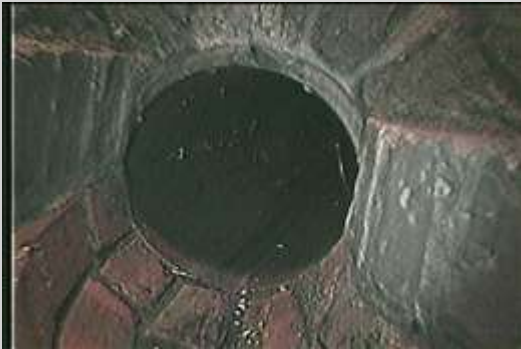
Pipe Out @ 12 O'Clock

Pipe Material: **Clay** ☐ Pipe Lined

Invert Depth: **11.60** (ft.) Flow Characteristics: **Slow**

Infiltration: **None** Pipe Seal Cond: **Unknown**

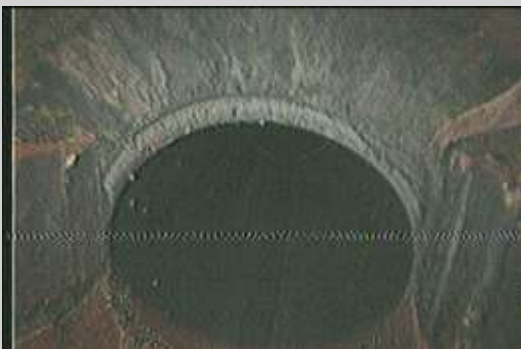
Pipe In @ 3 O'Clock

Pipe Material: **Clay** ☐ Pipe Lined

Invert Depth: **11.50** (ft.) Flow Characteristics: **Slow**

Infiltration: **None** Pipe Seal Cond: **Unknown**
